STUDY AND ANALYSIS OF FRACTURES IN GEARS FROM AUTOMOTIVE TRANSMISSIONS

Keywords: Fractures, Automotive Transmissions, Gears, Hardness.

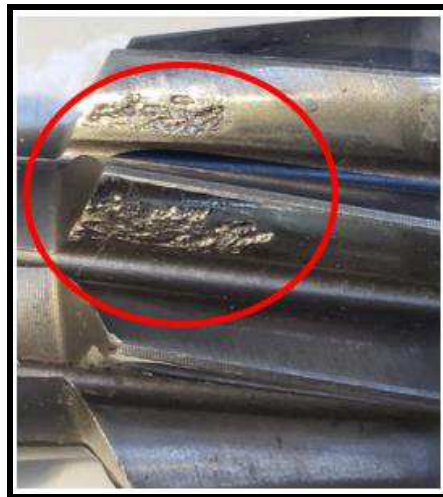
Figure 3 - Destructive Micro-Pitting.

The breakage due to contact fatigue is related to the criterion adopted to define production and quality standards. This type of failure occurs after a number of cycles, and is characterized by abrasions on the surface of the teeth classified as: macro-pitting, micro-pitting or destructive pitting, as shown in figure 3.

Contact fatigue occurs more frequently in pinions, which, because they are motor gears, are subject to greater numbers of cycles, so fatigue occurs before the crown. On the other hand, pinions with low or medium hardening can minimize the problem of “pitting” due to the wear and tear caused by the sliding of the pinion teeth in contact with the crown teeth. In figure 4, you can see a pinion showing wear and the crown showing “micro-pitting” (CASTRO, 2005). Lack of lubrication is also a cause of contact fatigue.

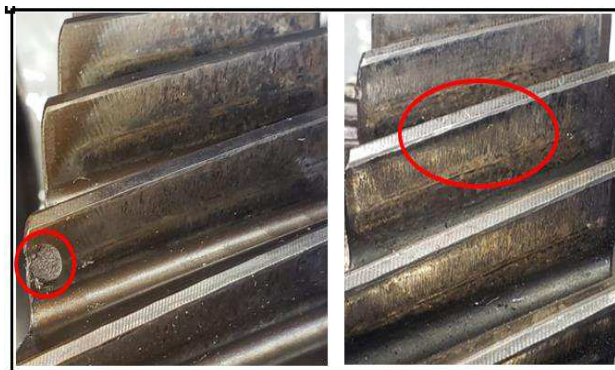
Figure 5 - "Scoring" Destructive Initial.

Scoring is characterized by scratches and scrapes, and the greatest occurrence is in contact between the top of the crown and the nose of the pinion, the lower region of the pinion, the upper region of the crown and counting the top of the pinion with the crown root.

It occurs mainly in gears that operate at high speeds like automotive ones, and is influenced by the materials used and their tempera. Affinity materials can fuse in contact teeth and pinions with surface hardness higher than crowns increase the resistance to this type of failure in the figure 5 illustrates an initial scoring.

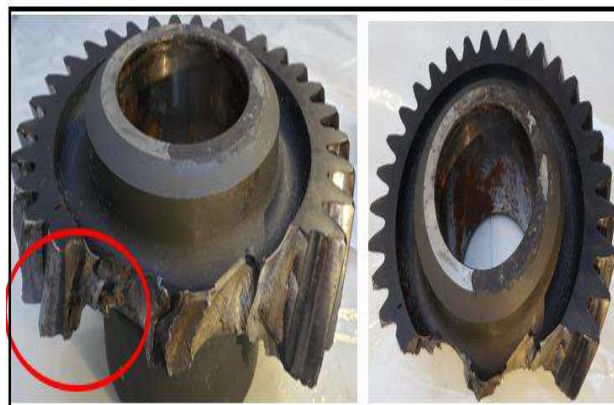
Figure 7 - Impact Break at the Tooth Root.

The fractures in the teeth of the gears usually occur from the rounding radius at the root of the tooth where it is most fragile, also due to contact fatigue from the primitive line and in the middle of the root between 2 teeth, these fractures being due to failures in the process of heat treatment causing high residual stresses and hardening, weakening the region.

Impact failures occur without the parts showing high cycling, being caused by overloads, for which the teeth were not designed or because the material showed some fragility in the figure 7 shows the characterization of an impact fracture.
